# Market Transformation to Achieve Large Scale Uptake of Sustainable Residential Renovation in New Zealand

## ABSTRACT

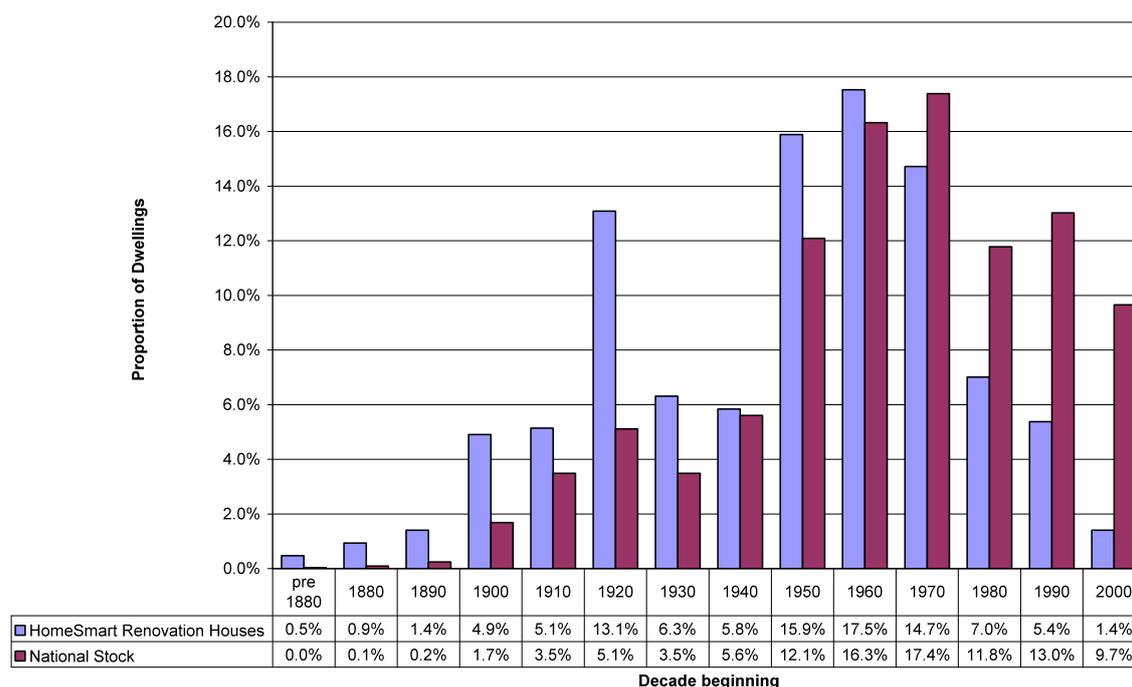
**Figure 1: Dwelling Age of the National Stock and Dwellings in the HomeSmart Renovation Project**

Almost half the dwellings assessed had been built prior to 1957. 15.6 percent of dwellings were built in 1978 or subsequently. Figure 1 compares the age profile of HomeSmart Renovation Project dwellings to the age profile of the National Stock.
